University of Sussex
Centre for Continuing Education

Course: X9070

**Archæological Investigation of
Chithurst Church,
West Sussex, 2007**

Edited by Robert Hutchinson FSA

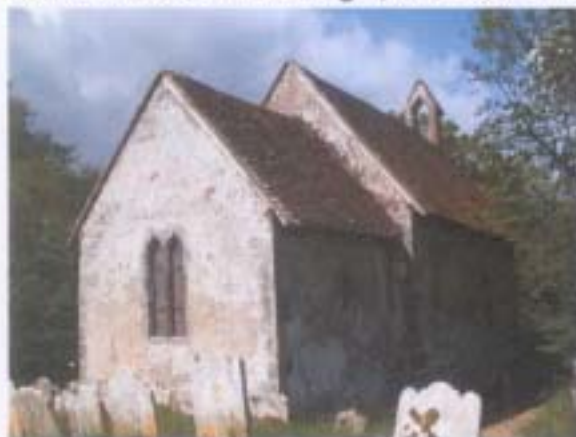
◀ Fig. 2: Chithurst church from the north-east, showing its two celled structure. The east window, with two ogee trefoil lights, was inserted c.1310.

2.1 The church is a two celled structure, with nave and chancel of c.1080, built of cream and ochre coloured sandstone rubble and quoins from the Hythe formation. (Figure Two). Dimensions are typical of a late Saxon/early Norman church: the nave measures 8-23 m. in length, and 4-57 in width and the chancel 3-66 x 3-35 m. Nave

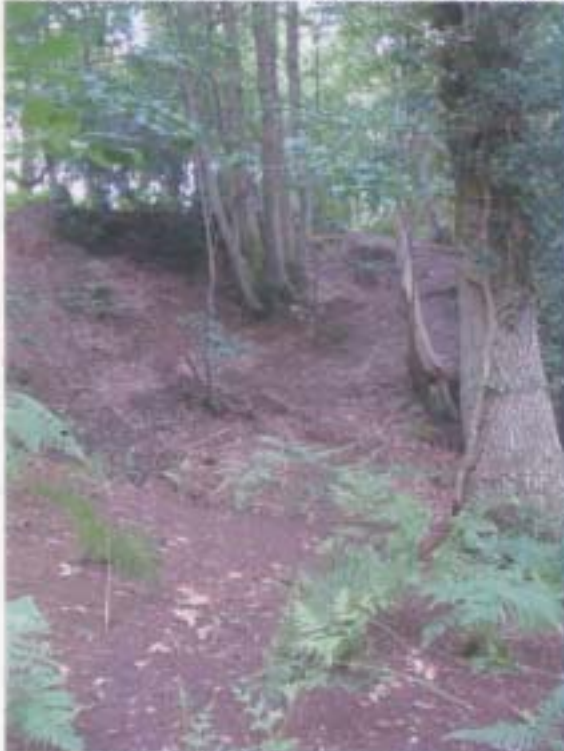
◄ **Fig. 4:** One of a number of ancient shallow quarry pits in the Hythe beds of Hammer Wood, (SU 843243) close to an east-west track linking up with the drove road passing the site of Chithurst Church, allowing convenient transportation of stone for the building of the structure. The gift of a quarry in the adjacent Wick and Holm Woods confirms medieval quarrying in this area. (Ken Jordan).

2.2 Stone for the church was probably quarried in Hammer Wood, one km. north of the site. A number of ancient shallow pits remain within the wood (*Figure Four*) revealing strata of the yellow, medium grained sandstone, which on superficial examination, seems to match. The stone was quarried in large blocks and transported by cart down the drove road adjacent to the church site. The Hythe beds sandstone is resistant to weather erosion but is also soft enough to be easily worked.

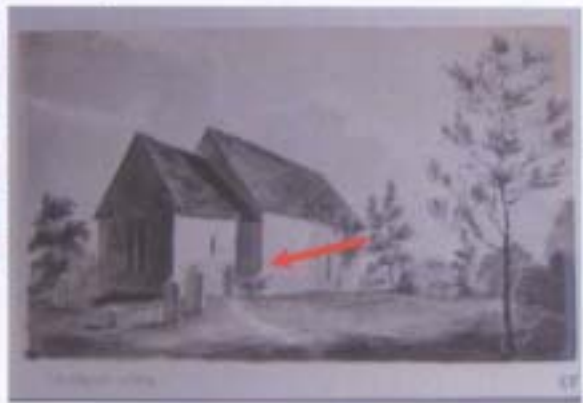
► **Fig. 5:** Drawing of Chithurst church, of c.1804, showing the priest's door in the north wall of the chancel. (Sussex Archaeological Society, Sharpe Collection, no 88, Michelham Priory).

2.3 A priest's door was inserted in the north wall of the chancel in c.1310. This was blocked in 1859, and the interior doorway jambs later masked by a wooden cupboard in the chancel. Antiquarian drawings show the door before closure.

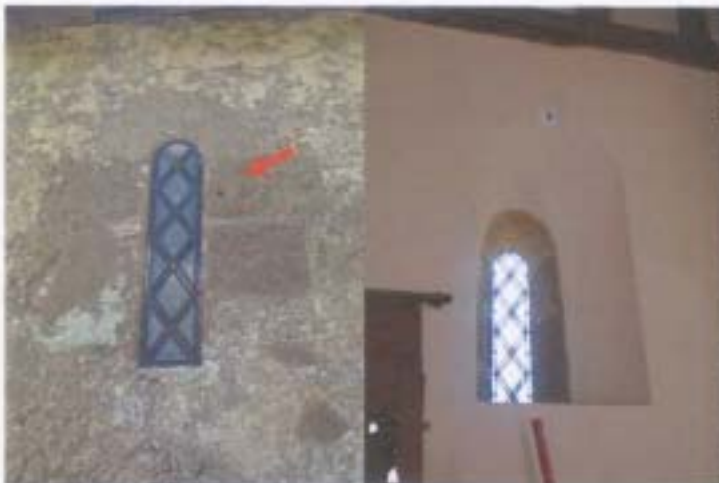
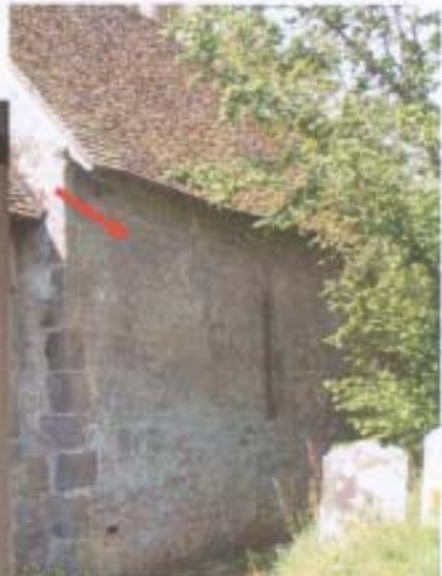
▲ **Fig. 7:** Exterior and Interior photographs of original unglazed window of c.1080 in north wall of chancel. Note wall thickness, (which averages 0.62 metres throughout the church) as displayed by the interior splay, and the hole on the right of the exterior window which may indicate a bracket for an outside shutter.

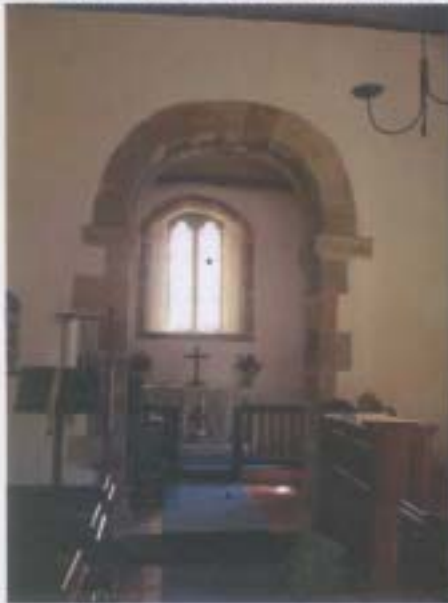
◀ Fig. 8: Chancel arch at Chithurst of c.1080.

2.4 Inside the structure, the chancel narrow arch, measuring 3.66 m. in height and 1.62 m. in width, is also original, although its chamfered imposts and plinths were crudely re-tooled with combing during the 1859 restoration.

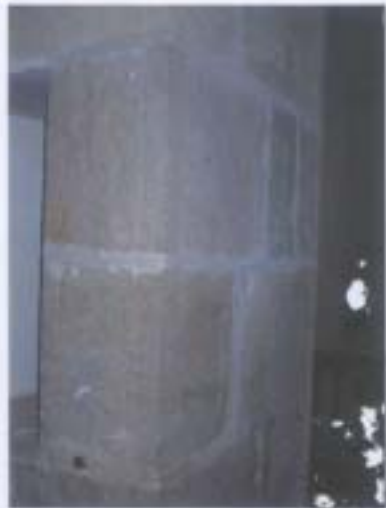
▶ Fig. 9: Crude re-tooling of chancel arch dating from the 1859 restoration. (Robert Hutchinson)

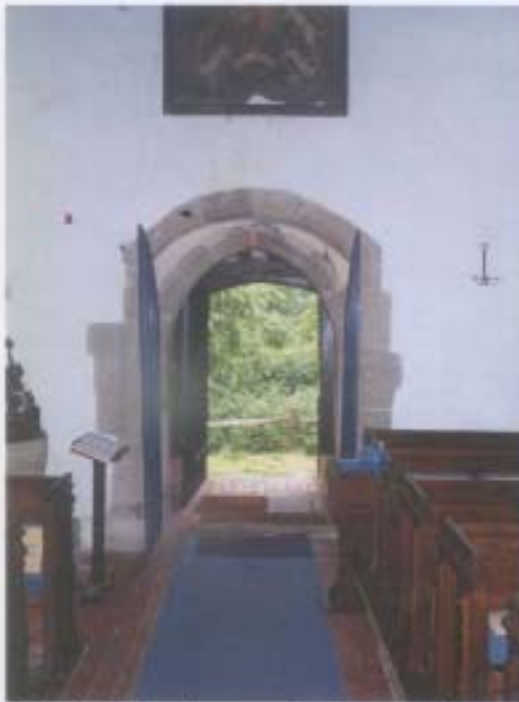
▲ Fig. 10: West doorway of c.1310 with plain pointed arch and segmental rear-arch.

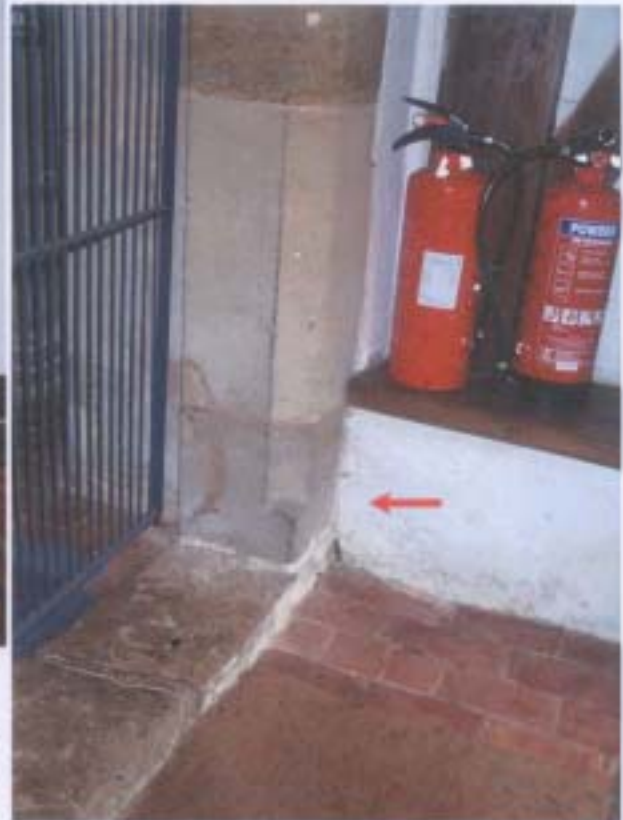
▶ Fig. 11: Original plinth of c.1310 west doorway with a later repair above. (Robert Hutchinson).

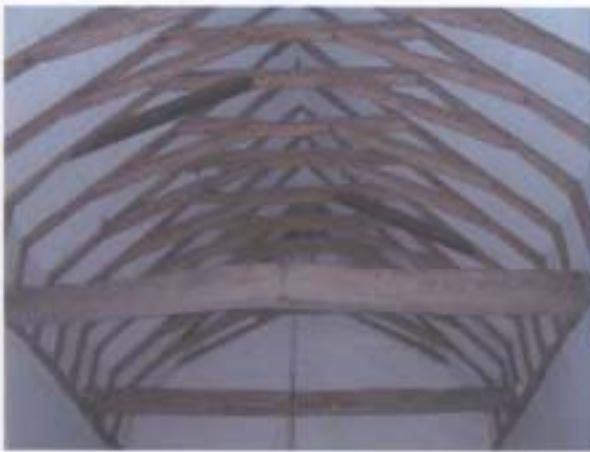
► Fig. 12: Nave roof, looking west, showing exposed trussed rafters and tie-beams.

2.6 The oak nave and chancel roofs are not coeval with the original structure. The nave probably dates from the work of c.1200 and the chancel from c.1310. The three tie beams and trussed rafters in the nave were exposed during the restoration of 1911 by Philip Mainwaring Johnston, when a plaster ceiling was removed.

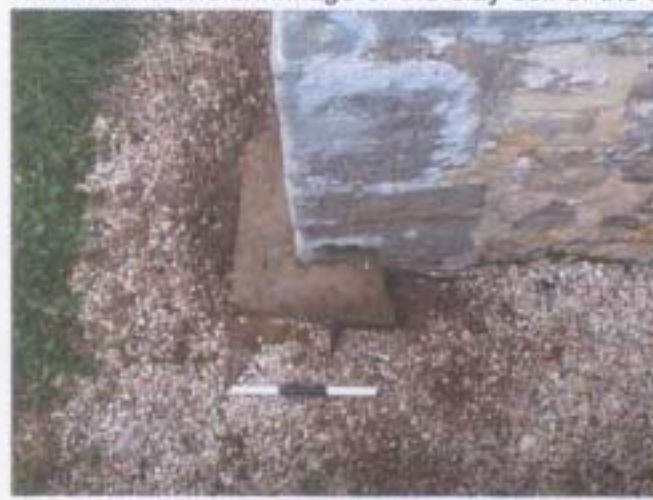
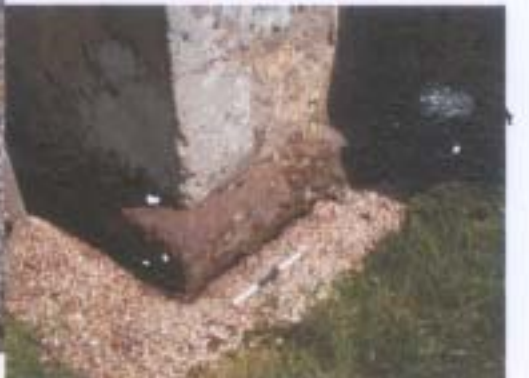
▲ Figs. 13 and 14: Large shaped slabs found as footings on (left) the south-east corner of the chancel and (right), the south-west corner of the nave. They both appear to be coeval with the original eleventh-century structure.

the footings of the south-east corner of the chancel and the south-west corner of the nave. Both closely resemble the type of sandstone used in the impostes of the chancel arch, which may indicate they are original work of c.1080: as both seem to be unnecessarily chamfered, it may be that these were intended for use in the interior but were pressed into service as emergency repairs. Replacement of the quoins, c.1310, at the south-west corner of the nave also suggests early remedial work to correct signs of subsidence of this section of the church. Two raking brick buttresses on the north-west corner of the nave and a third at the south-west were removed during the 1911 restoration. The architect, Johnston, retained one to support the wall of the nave at the latter.

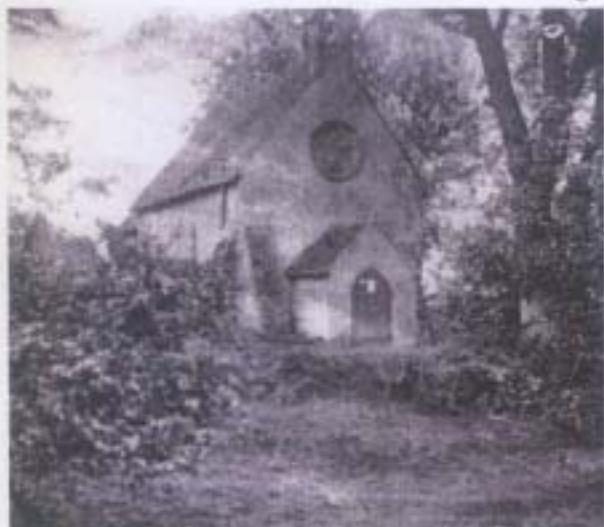
▲ Fig. 15: Photograph of west end of Chithurst church before 1911, showing now removed circular rose window from Iping church and raked buttress on west wall. (via Tony and Lesley Voice).

2.8 After the demolition of nearby Iping church and its second rebuilding of the nineteenth-century, a rose window was brought from there to be inserted high up in the west wall of Chithurst, as shown in a photograph taken before the 1911 restoration. The window was later removed, as it endangered the structural integrity of this part of the church and serious cracks remain in the west wall as evidence of the continuing problem, compounded by the weight of the single bell-cote above. (See Figures Fifteen and Sixteen).

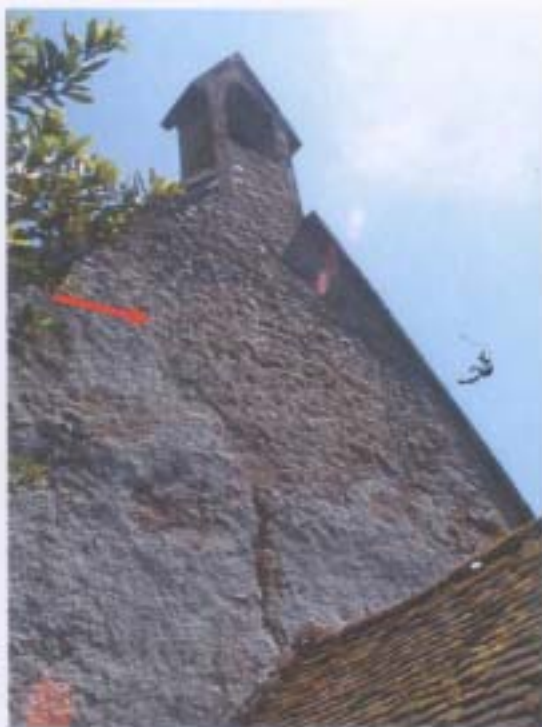
► Fig. 16: West wall of Chithurst church showing scar of removed rose window and settlement cracks above the roof line of the porch, worsened by the downward thrust of the bell cote above. (Robert Hutchinson)

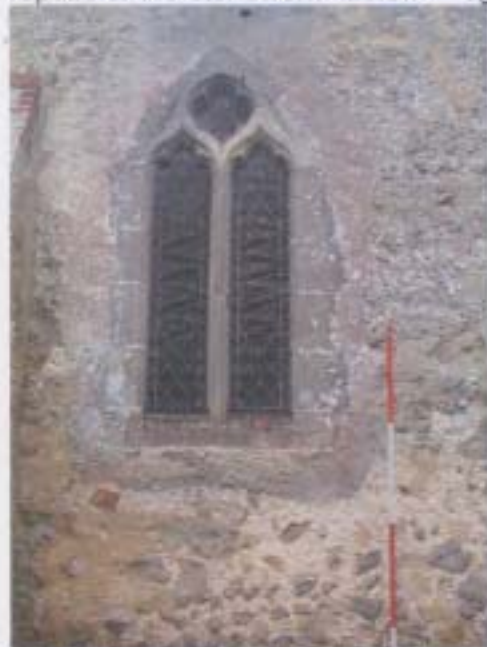
▲ Fig 17: Eastern-most window in the south wall of the nave, inserted in the 1850s, with evidence of a series of repairs to the masonry to correct subsidence.

2.9 The eastern-most window of the south wall of the nave was inserted in the late 1850s, possibly as a replacement for another of c.1310, with considerable repairs to the stonework below - again probably because of settlement problems.

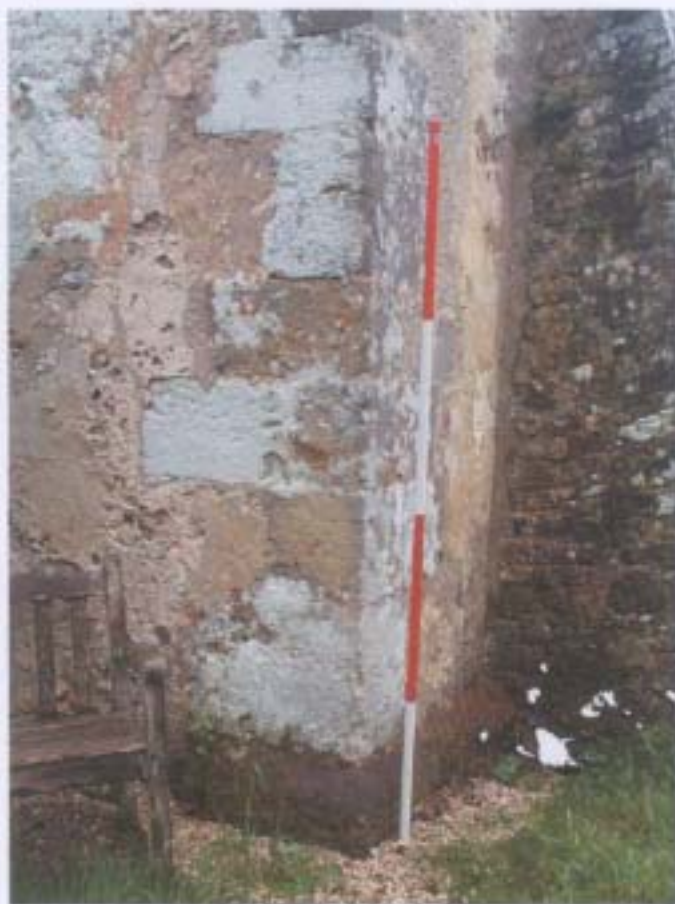
► Fig.18: Rough quoins of c.1310 as a repair to the south west corner (Robert Hutchinson)

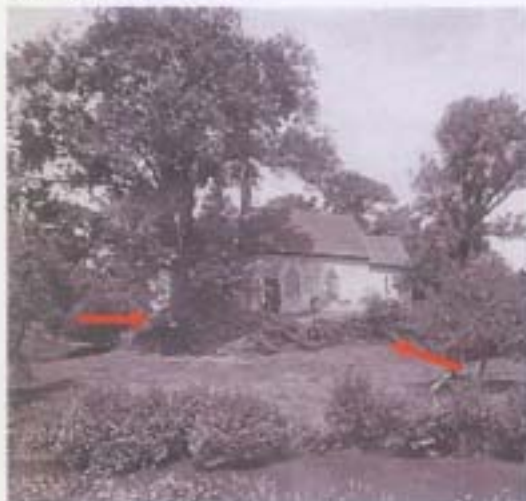
FIG. 21. CHITHURST, 1923.
Drawn by Robert Gurd, 1923.

► Fig. 21: Drawing of Chithurst Church from the grounds of the manor house, done by Robert Gurd in 1923, showing the pronounced slope of the mound on which the church is built. (Sussex Archaeology Society Library, Barbican House).

4.3 The scale of the enhancement is plainly visible, looking south from the churchyard extension, given by Commander Henry King RN, and consecrated on 18 June, 1862.²⁵ Here, earth has been banked up to build up the north side, possibly to create

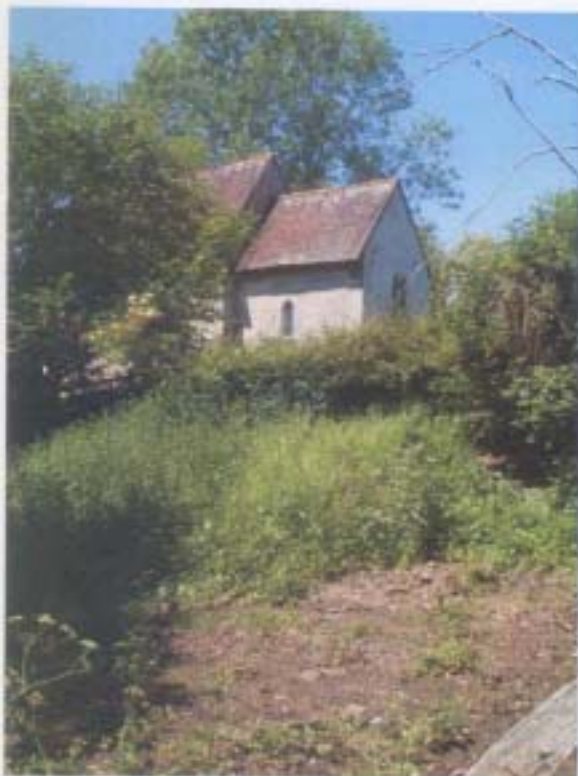
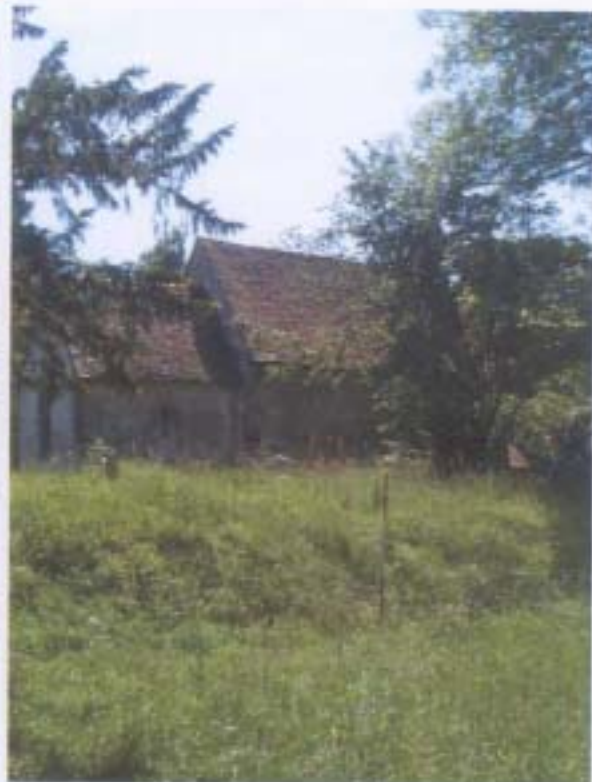
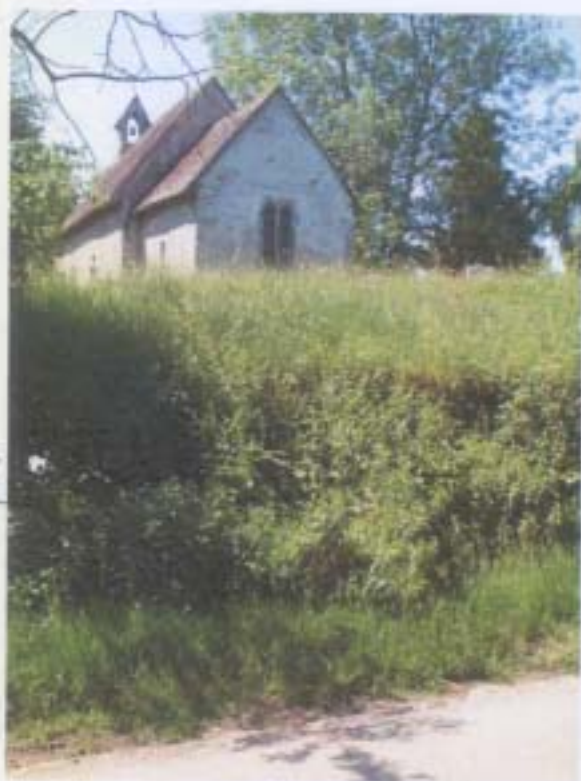
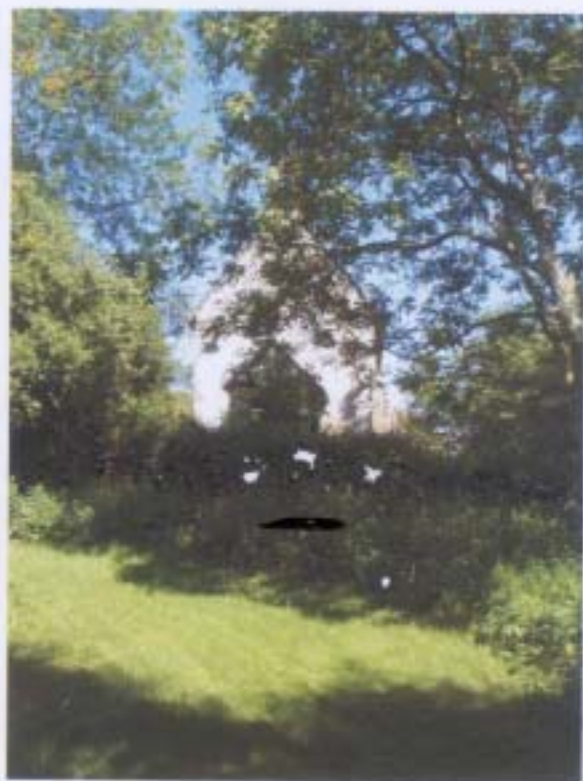
CHITHURST CHURCH AND MOUND. Clockwise from top left: (Fig. 23): from South-East, showing exposed mixture of sand, gravel, flint and chert, typical of river terraces and cliffs. (Fig. 24): from North, taken from the extension to the churchyard, showing a sharp bank, almost certainly artificially created or enhanced. (Fig. 25): from West, with possible indications of old revetment along top of mound that continues along the southern edge. (Fig. 26): from East, indicating the bank cut by the modern course of Chithurst Lane. (Robert Hutchinson).

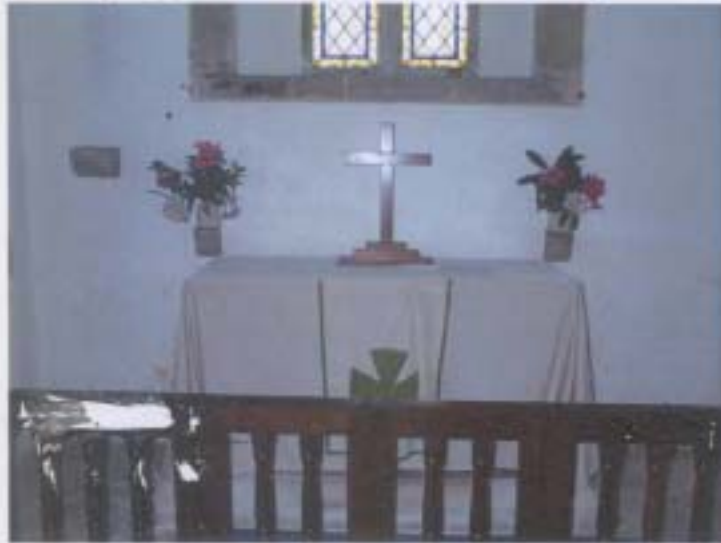
◀ Fig. 29: The modern altar table in front of two crude sandstone corbels which supported a Rood beam. At left, another corbel which probably supported an image of the Virgin Mary. The communion rails are

eighteenth-century, set in a later frame. (Robert Hutchinson).

5.0 There are no surviving indications of a Rood screen having been fitted within or near the chancel arch. However, two Hythe sandstone corbels, which probably date from Phase III (c.1200) on the east wall immediately behind the modern altar, almost certainly supported a beam on which the Holy Rood was placed.²⁶ They measure 12 cm.

in depth x 14 cm. height x 10 cm. in width. To the north of these, is a single carved corbel, 13.5 cm. tall x 12.5 cm. width of the same date which supported an image, possibly of the Virgin Mary, as in 1520, Robert Paynell of Terwick left in his will, a bequest of 'an ewe to [pay for a candle for] o' lady Light of Chethurst.'²⁷

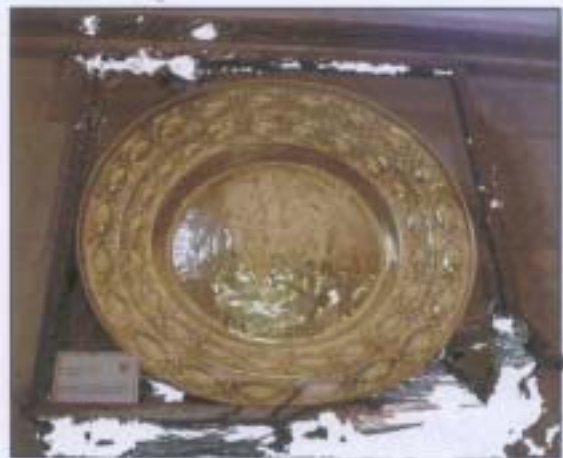
► Fig. 30: The Chithurst brass 'Adam and Eve' alms dish, now in the Treasury of Chichester Cathedral. (Tony Voice).

5.1 A brass alms dish formerly stood behind the altar but is now held in the Treasury of Chichester Cathedral. The dish, 37.4 cm in diameter, shows Adam and Eve in the Garden of Eden. A similar dish with the same design, made in Nuremburg in 1487, from the church of Foulis Easter in Perthshire, is now in the Royal Scottish Museum in Edinburgh. Stylistically, therefore,

the Chithurst dish can be dated to the late fifteenth-century. It is not known how the artefact came to Chithurst – a drawing of it *in situ* is dated 1848²⁸ – but another, portraying Adam and Eve, of seventeenth-century date, was at North Marden, in West Sussex.²⁹

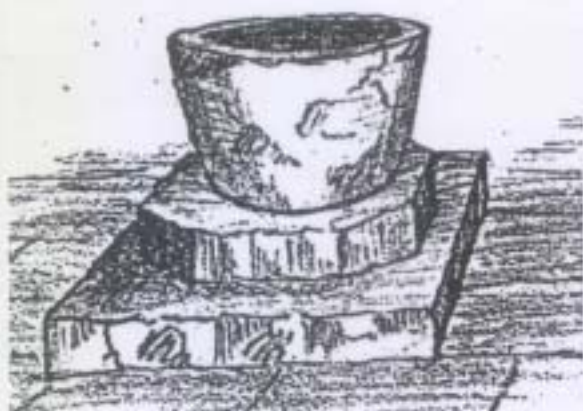
◀ Fig. 35: Drawing of Chithurst font by Adelaide Tracy in 1848 before the nineteenth- and twentieth century restorations, (via Tony & Lesley Voice).

5.6 The crude early twelfth-century (Phase IIB) tub-shaped Bargate stone font on a later octagonal base, is on the south side of the nave at the west end. It belongs to a group of early West Sussex fonts at Didling, Littlehampton and Walberton and is probably the work of an itinerant mason. It was re-tooled in 1859, when it was probably re-set. Its wooden font cover was recorded in 1891.

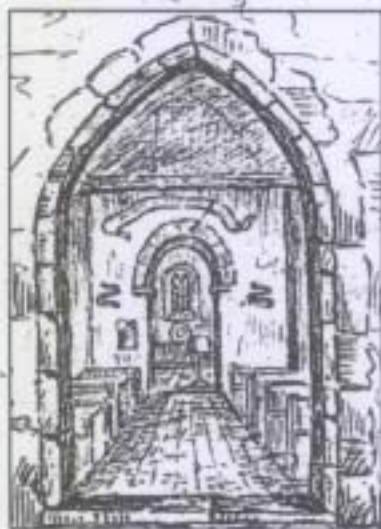
▶ Fig. 37: Royal arms, as borne 1810-37, on a framed painted canvas panel recently moved to hang high on the west wall of Chithurst church, above the doorway.

5.8 Above the west door hangs a canvas panel with a painted Royal Arms, slightly damaged top and bottom, and displaying the arms as borne in 1810-37. (Figure Thirty-seven).

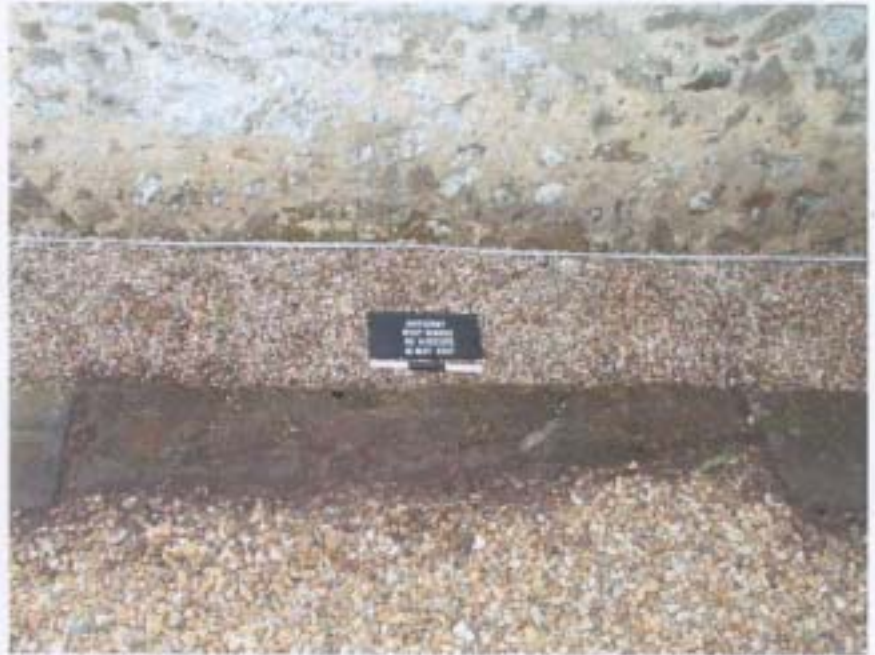
► **Fig.40:** Worn and badly cracked floriated cross slab, (Slab 2), fourteenth-century, probably to a priest; second from the east in the line of slabs running east-west in path alongside north wall of Chithurst church.

8.0 Outside the north wall of the nave, is a line of ten grave-slabs lying east-west in the gravel path skirting the church. The second from the east is a fourteenth-century coped slab (163 cm in length tapering from 36 to 22 cm in width), bearing the worn remains of a floriated cross, probably to a priest at Chithurst and almost certainly removed from the chancel.

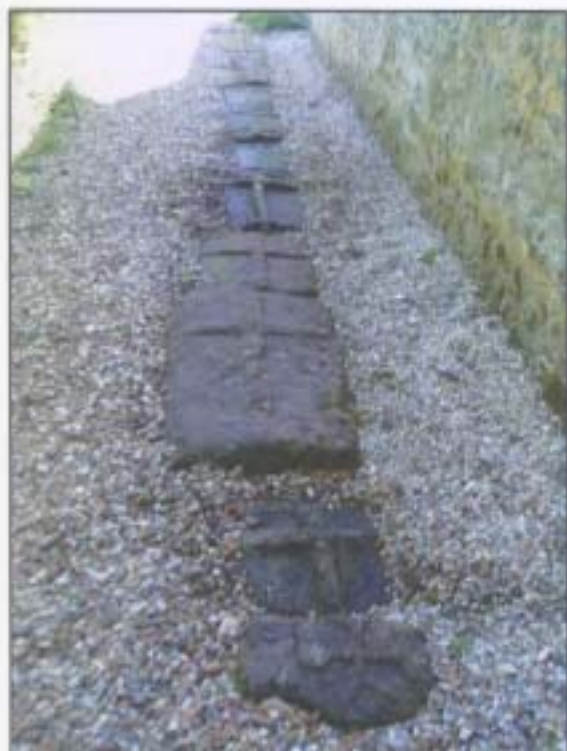
◀ Fig. 41: The line of slabs in the gravel path in front of the north wall of Chithurst church, seen from the west. (Tony and Lesley Voice)

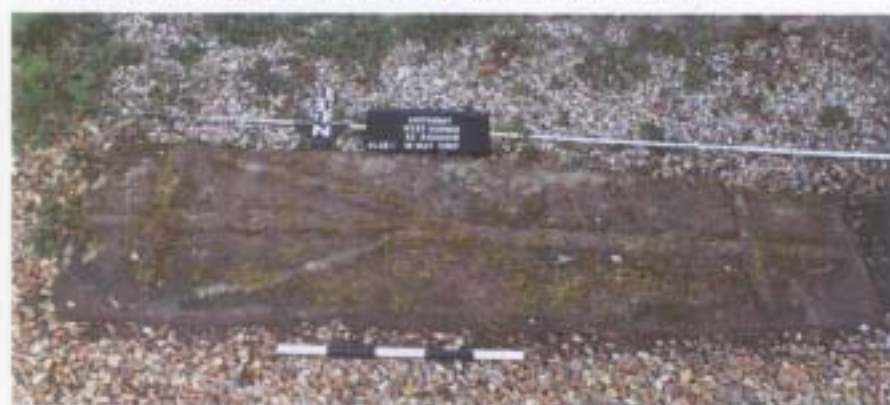
◀ Fig. 42: Slab I: 'Y'-shaped cross with upper and lower horizontal bar; 174 cm. in length; 53 cm. width at top, narrowing to 40 cm. at base. Cross vanes 3 cm. deep in relief. Similar in design to a slab at Stedham and probably eleventh-century in date.

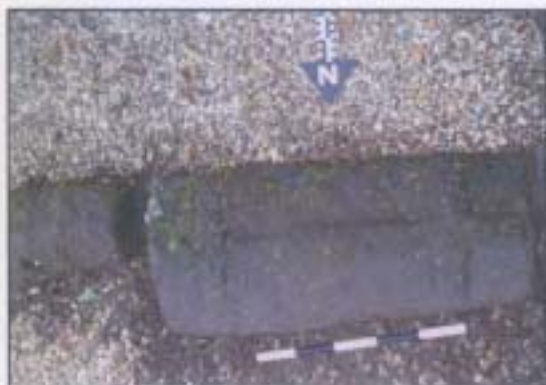
▲ Fig. 43: Slab 3 (Possibly cut-down) – cross with double arms, now 92 cm. in length; 40 cm. in width, tapering to 32 cm. at west end. (Tony & Lesley Voice).

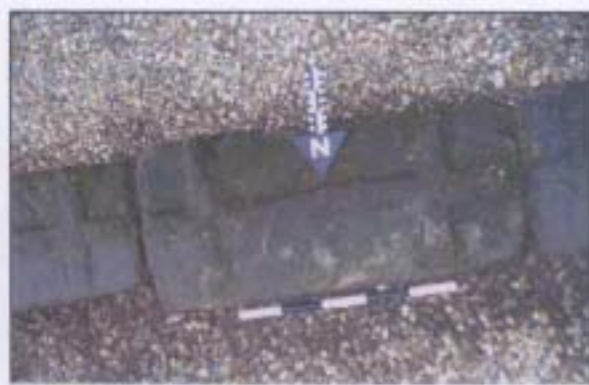
▲ Fig. 44: Slab 4 (again, possibly cut-down) – cross with double arms, now 89 cm. in length and tapering from 40 cm. width down to 33 cm. (Tony & Lesley Voice).

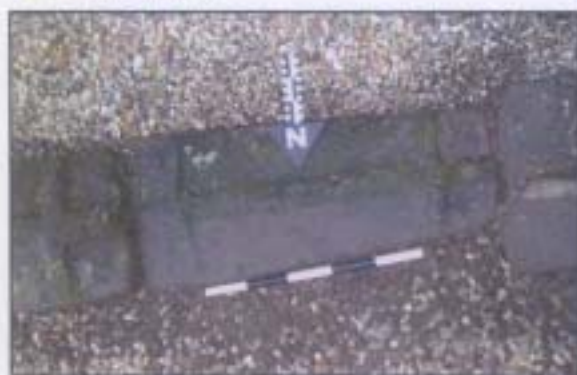
▲ Fig. 45: Slab 5 (again, possibly cut down – cross with double arms, now 81 cm. in length and 33 cm, tapering down to 24 cm. in width. (Tony & Lesley Voice).

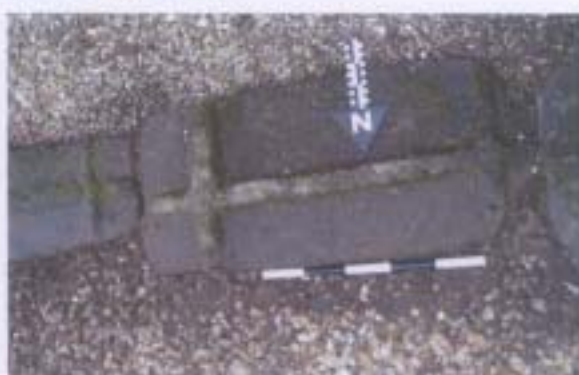
▲ Fig. 46: Slab 6 (possibly cut-down, broken at west end) – cross with double arms, now 90 cm. in length and 40 cm. width. Heavy relief carving, 4 cm. deep. (Tony & Lesley Voice).

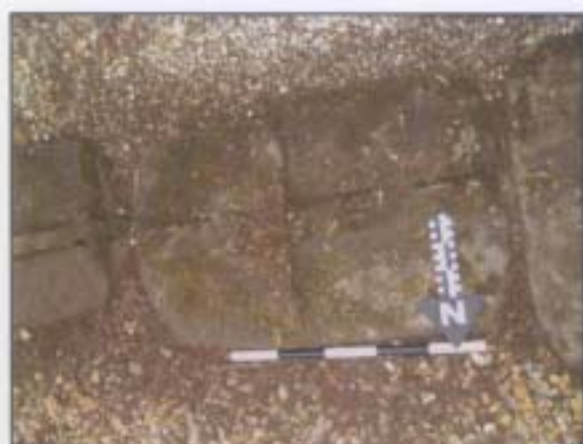
▲ Fig. 47: Slab 7, cut down – 64 cm. in length, and tapering upwards from 30 cm. in east to 40 cm. in west. Very deep relief carving of single-armed cross, varying from 7 to 8 cm. deep. (Tony & Lesley Voice).

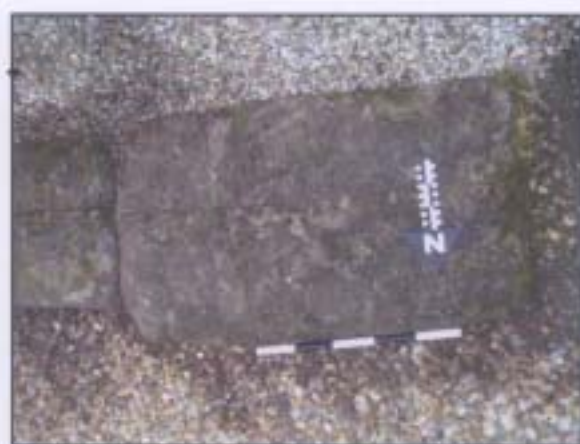
▲ Fig. 48: Slab 8: 103 cm. in length, tapering from 59 cm. in east to 51 cm. in west. West end very worn and relief of cross almost effaced. (Tony & Lesley Voice).

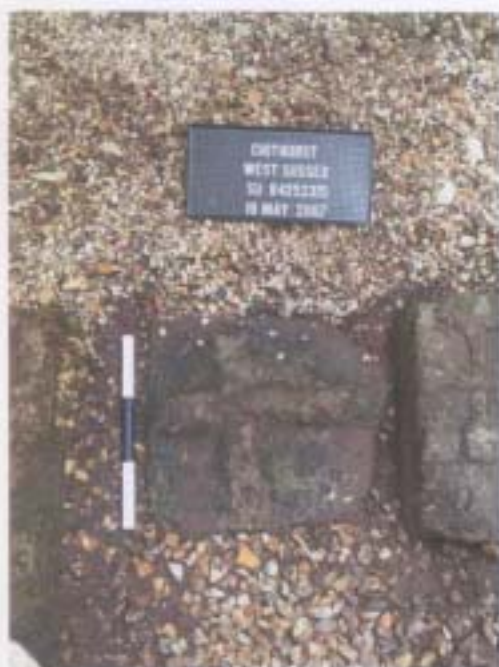
◀ Fig. 49: Slab 9. Cut down slab measuring 33 cm. in length and 30 cm in width. The size would suggest it is probably not a grave-marker – possibly a cover for the grave of a child. (Robert Hutchinson).

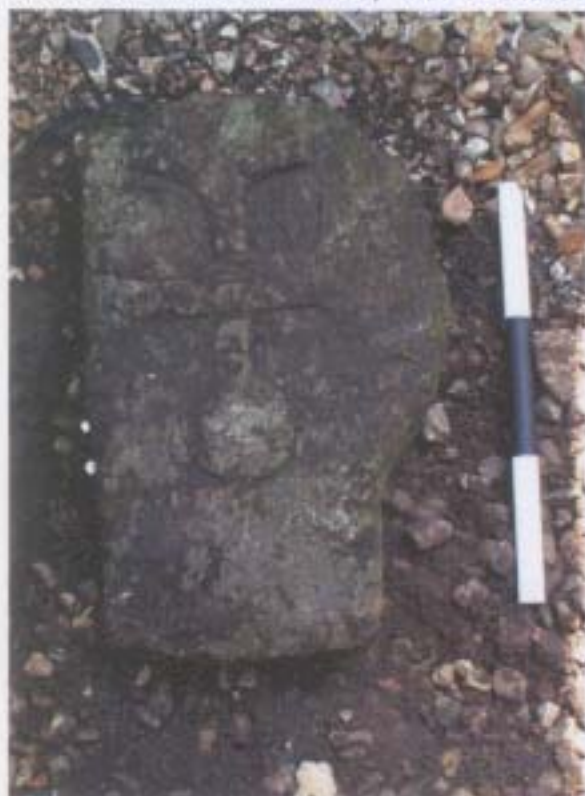
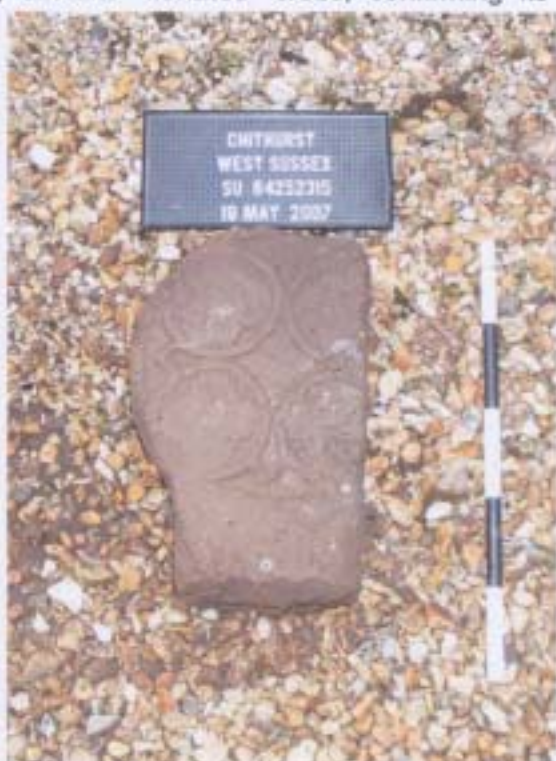
▲ Figs. 50 and 51: The Chithurst 1 grave-marker: left – obverse, showing a Latin cross with bulbous terminations and right – reverse, showing a floriated cross. (Robert Hutchinson).

narrowing down to a rectangular base that was buried; the characteristic "lollipop" shape of this type of monument. It measures 39 cm in length, of which the top comprises 25 cm. Depth is 13 cm. While dating such monuments is always difficult, Chithurst 1 is probably late thirteenth/early-fourteenth-century. On turning over the slab, the reverse was also found to be carved, with a shallow, delicate floriated cross, confirming its

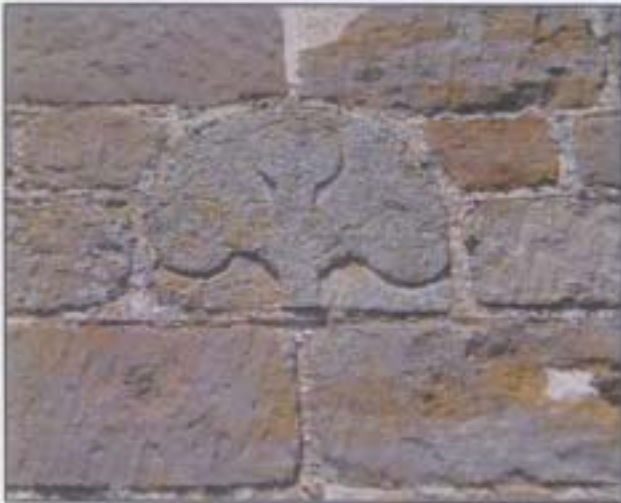
◀ Fig. 52: Fragment of a grave-marker built in the south wall of the new church at Stedham, south-west of the porch – during its rebuilding in 1850. Its design resembles that of Chithurst 1. (Tony & Lesley Voice).

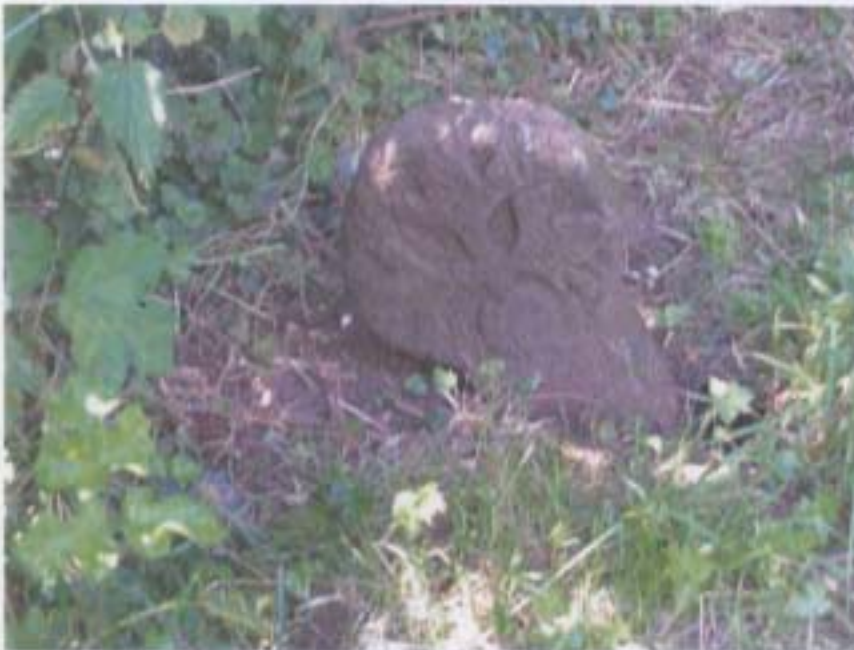
◀ Fig. 53: Chithurst 2 at the moment of discovery amidst undergrowth on the southern boundary of the churchyard. (Ken Jordan).

9.2 Chithurst 2 is a very similar example with crisp carving extant on the obverse, and remains upright, probably at the head of its original

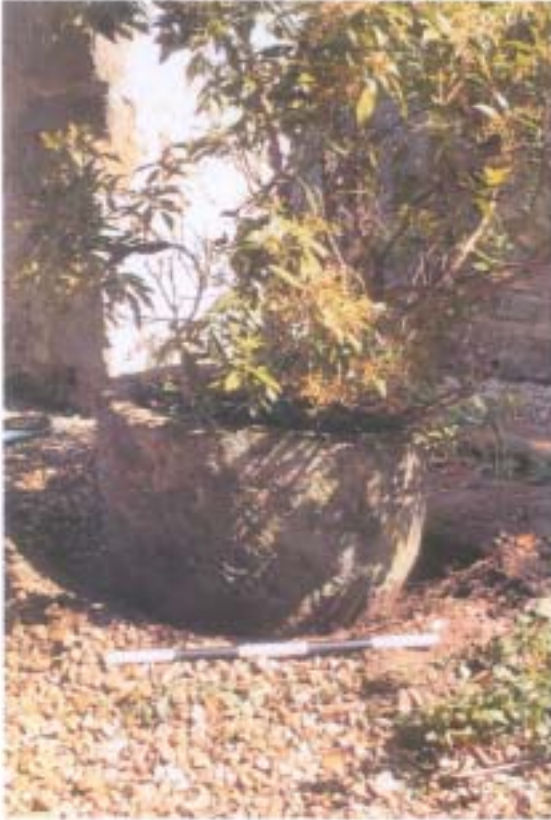
◀ **Fig. 58:** *Eleventh-century font, possibly from Iping church, now outside the porch of Chithurst church. (Robert Hutchinson).*

10.0 North-east of the west porch of Chithurst church is a large stone tub, holding a shrub. Examination of this artefact confirmed that it is a sandstone font that can be dated to the eleventh-century and is therefore earlier than the one in the church. Bearing in mind the transfer of the rose window from Iping church at its demolition in the late 1880s, this could well be the ancient font from Iping church.

10.1 There are no marks on the rim of the font to indicate that a lockable cover was ever present to protect the holy water inside it. The font currently sits on a base of concrete. It was not possible to check if the font is lined with lead or indeed, the depth of the bowl. The font measures 64cm. in diameter and has a depth of 39cm. The lip of the bowl has a width of 8cm.
